USAERADL Test Report 1885

ENGINEERING-TEST REPORT ON
SHORT-RANGE MISSILE LAUNCH LOCATOR AN/TNS-5

August 1962

UNITED STATES ARMY
ELECTRONICS RESEARCH AND DEVELOPMENT LABORATORY
FORT MONMOUTH, N.J.

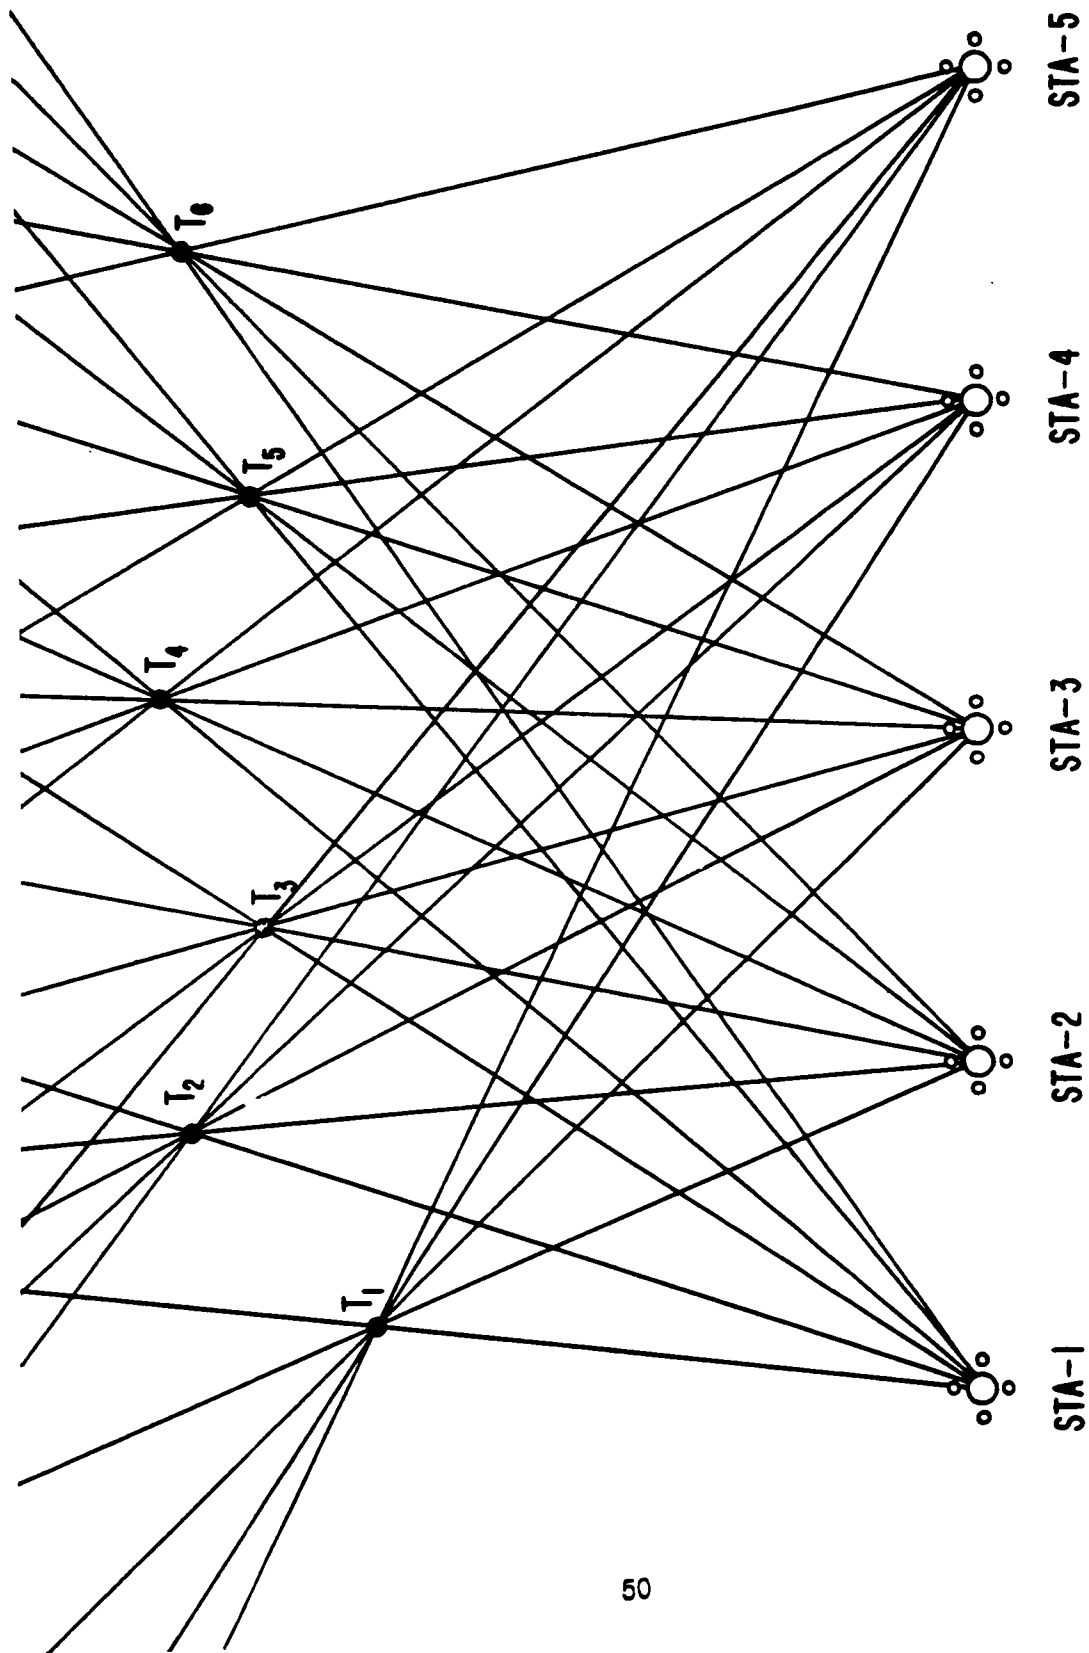
FIG. 2 INTERSECTIONS PRODUCED BY FIVE AN/TNS-5
STATIONS RANGING ON SIX TARGETS.
